IDENTIFYING AND REMOVING POLLUTANTS FROM HEAT RECOVERY VENTILATORS

By: Terry Watters
Sustainable Housing and Education Consultants Ltd.

February 1999

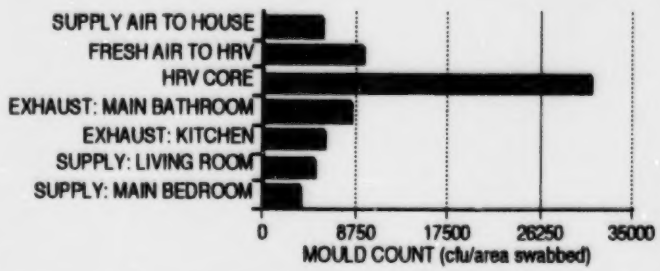
CHART III.C: PRE CLEANING AVERAGE SWAB MOULD COUNTS BY LOCATION

Precleaning testing indicated that, on average, the highest surface mold counts at common sites were at the HRV core (30959 CFU/area swabbed) and at the fresh air intake to the HRV (9322 CFU/area swabbed). Prior to cleaning, on average, the lowest counts were found in the main bedroom supply duct (3411 CFU/area swabbed), although the living room supply, kitchen exhaust and supply air to house were within 3% of the main bedroom supply. Post cleaning results indicated that, on average, the highest surface mold counts were at supply air to house (11309 CFU/area swabbed), and the lowest counts were at the living room supply (188 CFU/area swabbed). The average overall reduction of discernible mold counts was 29189 CFU/area swabbed. All swab sites showed a reduction in CFU/area swabbed after cleaning except the main bedroom supply and the supply air to house. Post cleaning swabs showed a redistribution of mold counts (see charts III.D and III.E).
